Coastal Adaptation Strategies: Case Studies

National Park Service Report 2015

Edited by Courtney A. Schupp¹, Rebecca L. Beavers¹, and Maria A. Caffrey²

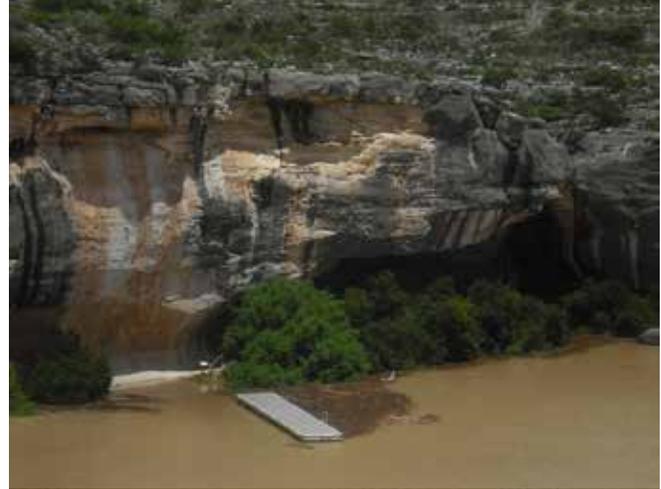
The reservoir level was 344 m (1,130 ft) mean sea level in July of 2010, nearly reaching the base of the pictograph panel. By May of 2013 the reservoir had dropped to a record low of 322 m (1,055.9 ft) above mean sea level, leaving the canyon bottom completely dry. Image credit: Randy Rosales, Texas Parks and Wildlife Department.

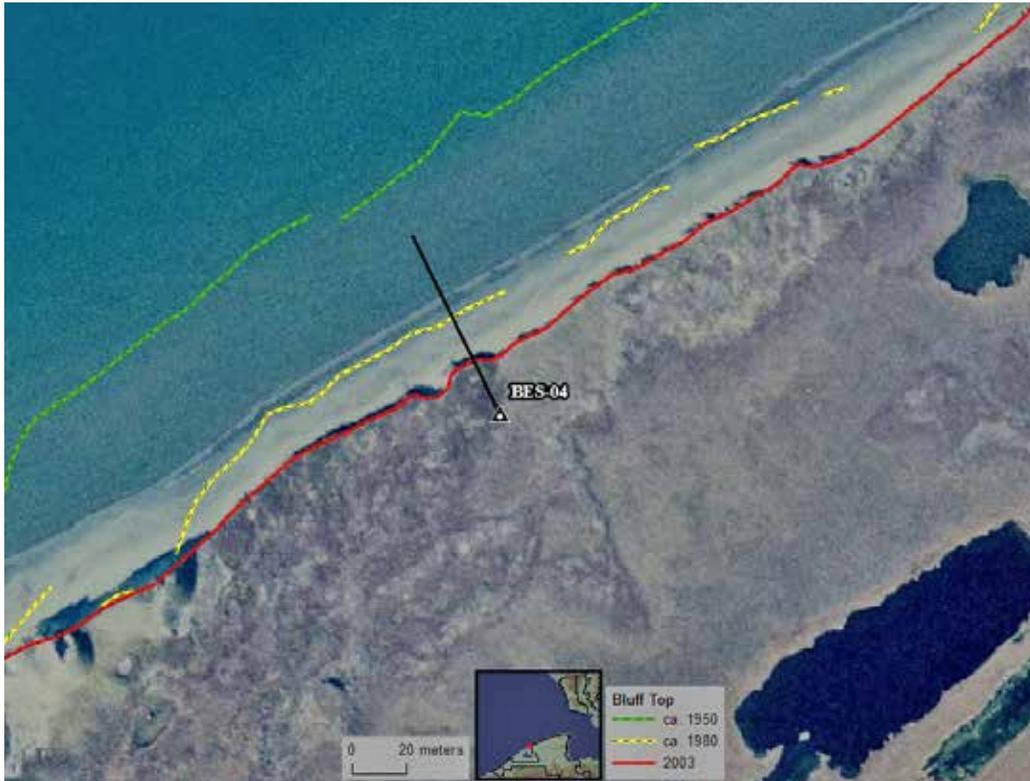
Bluffs along the coast eroded 78 m (256 ft) in only 54 years. Image credit: NPS I&M Program.

The 1,600 km (1,000 mi) of coastline along the parks are experiencing increased storm impacts due to climate change effects including rising sea level, melting permafrost, increasing storminess, and the failure of shore ice to form its usual protective barrier against wave erosion during open water season, including storms in the late fall. The Alaskan Arctic has experienced average temperature rise at twice the rate of the rest of the world, and precipitation patterns are changing. Seasonal (winter) sea ice is not forming to its previous extent and thickness, and thick multi-year ice has mostly disappeared. Satellite data indicate that the extent of the sea ice is decreasing by 3% per decade, and submarine data show that the thickness has decreased by up to 1 m (3.3 ft). The ice plays a role in surface reflectivity, cloudiness, humidity, exchanges of heat and moisture at the ocean surface, and ocean currents. Summer ice is projected to disappear over most of the Arctic Ocean by 2020. Permafrost, which protects cultural resources by preserving organic materials, has warmed by up to 2°C (3.6°F) and is melting.

Both parks preserve some of the earliest most significant archeological sites in North America including ancestral villages of the Inupiat people. Some of these prehistoric sites are being lost due to destabilization of the coasts and the resulting erosion that can be up to 3.7 m (12 ft) per year. As the permafrost that encases the soil of the region melts, the stratigraphy, artifacts, and buried house remains that make up a typical site are exposed and then become victim to mechanical erosion from the waves and thermal degradation from the warmer temperatures that prevail on the bluff faces.

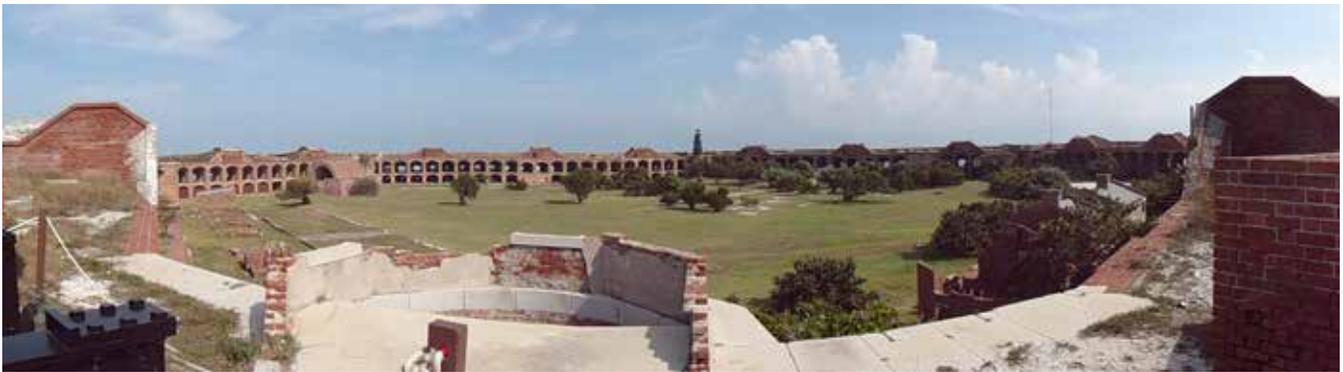
Historic Fort Jefferson is a six-sided structure built on a landform that is impacted by coastal processes.
Image credit: Marcy Rockman, NPS.

For more than 165 years, Fort Jefferson on Garden Key has exhibited incredible resilience to storms and the marine environment of the Dry Tortugas. Still the structure is deteriorating. The fort is a mid-19th century Third System Coastal Defense. It is an unreinforced masonry structure composed of coral concrete faced with

brick, with six sides and three tiers. It is surrounded by a 21 m (70 ft) wide wet moat that is separated from the open waters of the Gulf of Mexico by a masonry wall, formally called the counterscarp. The counterscarp sits approximately 2 m (6 ft) above the low water line and 1 m (3 ft) above high tide. The moat and counterscarp were designed to keep would-be attackers at bay and to provide a structural first line of defense for the fort against the sea.

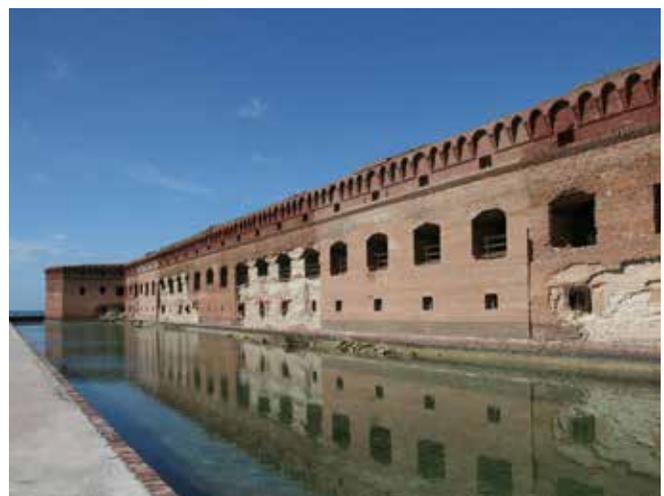
Fort Jefferson needs repairs to its front and moat wall.
Image credit: Kelly Clark, NPS.

Throughout the architecture of the fort, there are iron components embedded within the masonry that served various functions, including water collection, supports for catwalks, and, most importantly, protection against enemy fire. In this salt water environment, the wrought-iron has rusted and expanded, pushing the brick apart and causing serious structural damage to Fort Jefferson's exterior scarp walls; large sections of the fort walls have collapsed into the moat.

The moat wall surrounding the fort also needs repairs in many places. Because it is an integral part of the site design and protects the fort from wave forces, it also protects the investment in stabilization of the fronts.

Through strategic planning, informed decision making, and responsible investments, the park is trying to mitigate the effects of the environment over time. This approach has resulted in removing the corroded iron shutter assembly components and stabilizing the exterior masonry walls. Preservation and stabilization work on the fort has occurred on an intermittent basis since the 1990s. The moat wall has been worked on intermittently since the 1960s. For both structures, the scope of work has been guided by the amount of available funding. At this point in time, all six sides of Fort Jefferson have received some form of stabilization, but the work is not complete. The main priority for the park is to complete the removal of the remaining iron shutter components embedded in the exterior scarp wall (fronts 3 and 2) and to stabilize as much of the brick work from the top of the parapet to the low water line with selective brick replacement and repointing. The estimated cost to finish these stabilizing measures by 2018 is just under \$12 million.

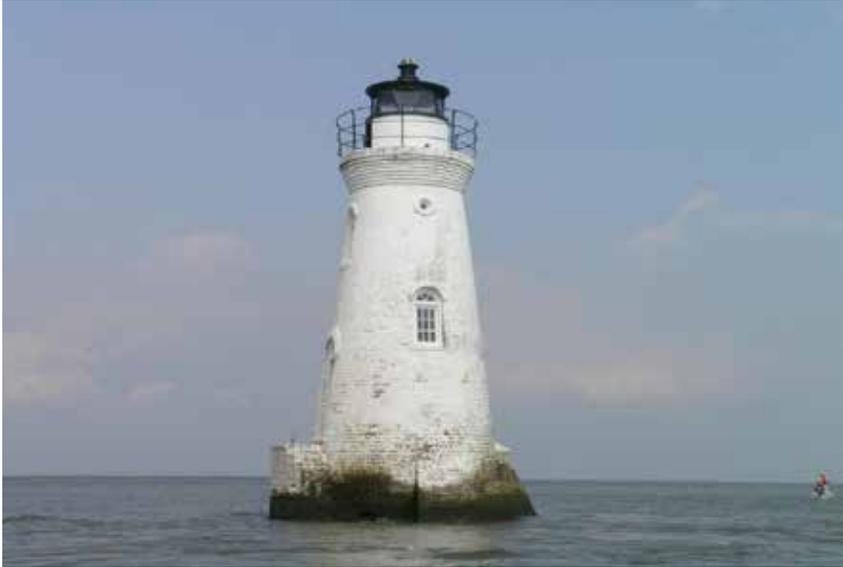
The Cockspur Lighthouse at Fort Pulaski National Monument needs to be stabilized. Image credit: Mike Eissenberg, NPS.

The historic revetment around the Cockspur Lighthouse has eroded away in the past 30 years, and a portion of the original wooden foundation has been exposed to shipworm damage. Ongoing erosion around the revetment has led to concern about the possibility of severe structural damage in the next few years.

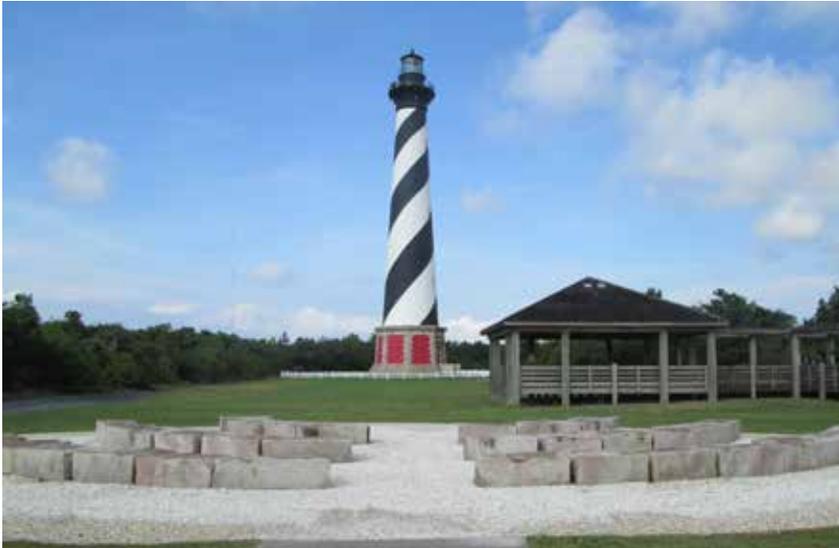
The Cape Hatteras lighthouse was moved inland using a railway in 1999. Image credit: NPS.

Following so many unsuccessful attempts to protect the lighthouse with hard structures, the “Move the Lighthouse Committee” was formed in 1986 and became strong proponents of relocating the lighthouse inland. In 1988 the National Academy of Science also recommended that the lighthouse be moved. The National Park Service (NPS) released a statement in December 1989 formally announcing the decision to move it.

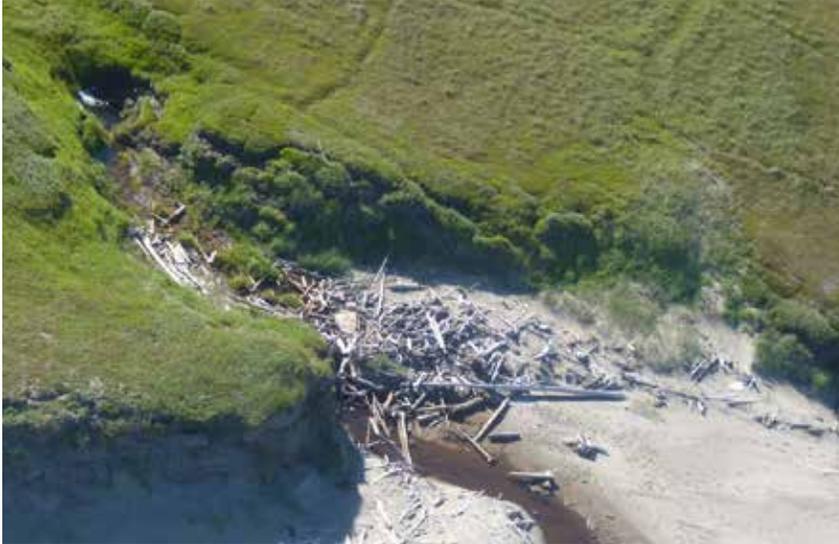
Coastal bluffs are eroding as a result of permafrost thawing and coastal storm erosion. Image credit: Tahzay Jones, NPS.

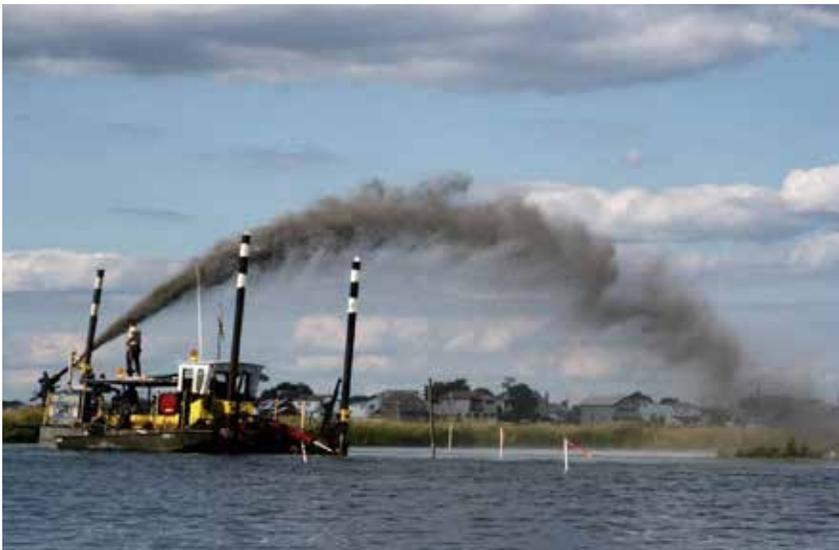
Salt marsh restoration in Jamaica Bay has tried a variety of experimental techniques to increase marsh elevation, including spraying the marsh surface using a swing-ladder dredge. Image credit: USACE New York District.

Future restoration efforts may be inhibited by the availability of a cost-effective clean source of sediment. NPS and park standards for sediment quality that exceed Environmental Protection Agency and New York Department of Environmental Conservation standards were met with resistance from funding partners. Fund transfer mechanisms among state and federal partners will likely be a recurring challenge. Another challenge is the inability of restoration fund sources to support basic research that would improve restoration by optimizing techniques or identifying the causes of marsh loss. For example, this project would have benefitted from a better understanding of the tidal range, and the elevation range for saltmarsh cordgrass (*Spartina alterniflora*) growth within Jamaica Bay, in order to restore marshes to the maximum elevation at which the desired habitat could establish. Site-specific data relating to shallow subsidence and compaction would have improved estimates for the fill volume required to achieve design elevations.

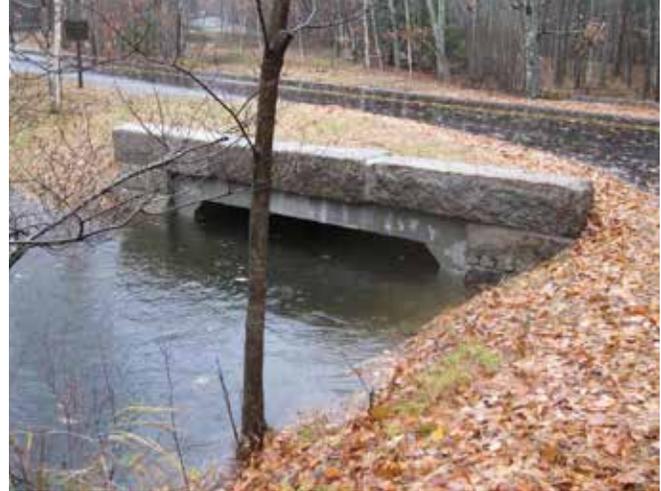
Headwall and culvert after rehabilitation at Sieur de Monts Spring site. Image credit: Rebecca Cole-Will.

Acadia National Park in Maine is working to rehabilitate historic road systems and culverts that have been damaged by increasingly frequent flooding and erosion events that were causing maintenance and visitor use closures.

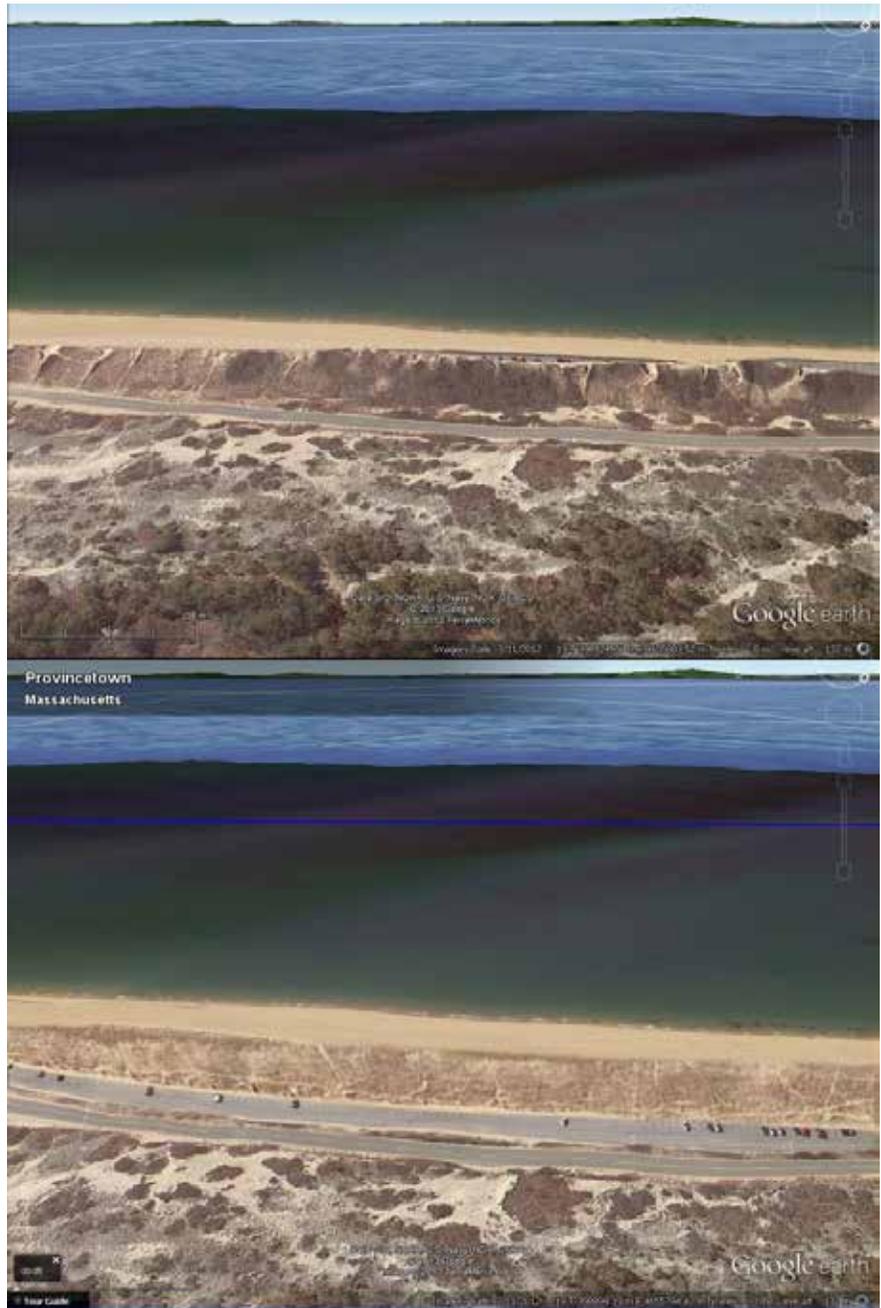
Top: Before the Herring Cove redesign, visitors parked between the beach and an artificial dune. Image credit: Google Earth. **Bottom:** Following the redesign, the parking lot will be adjacent to the road, and the artificial dune will be reshaped to mimic adjacent natural topography. Image credit: Mark Adams (NPS) conceptual visualization using photographs from Google Earth.

In December 2011, the Herring Cove visitor facilities were impacted by a storm that

undermined both parking lots and damaged an asphalt revetment protecting the bathhouse and north parking lot. The park needed to design replacement facilities that would continue to serve visitor needs, avoid placement of permanent infrastructure in highly vulnerable areas, and consider shoreline change and coastal policy.

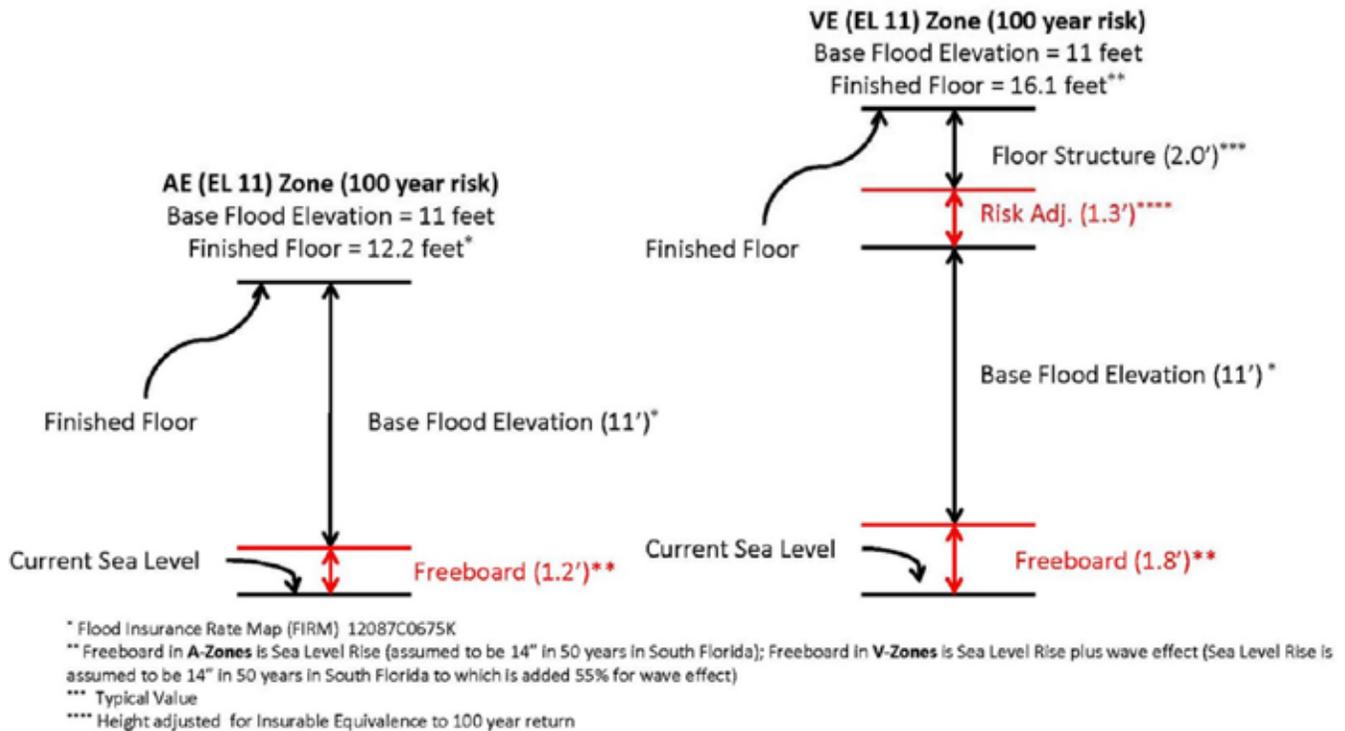
Everglades National Park is redeveloping the Flamingo area, including proposals to mitigate risk by elevating structures. Heights include the incorporation of sea level and storm surge scenarios. Image credit: Everglades National Park.

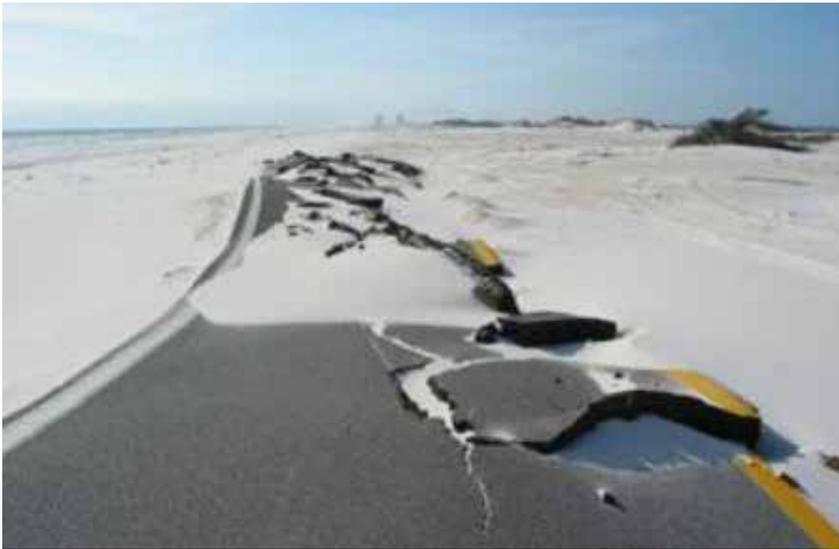
Storms regularly damage the Fort Pickens Road, resulting in extended road closures and high repair costs. Image credit: Federal Highway Administration.

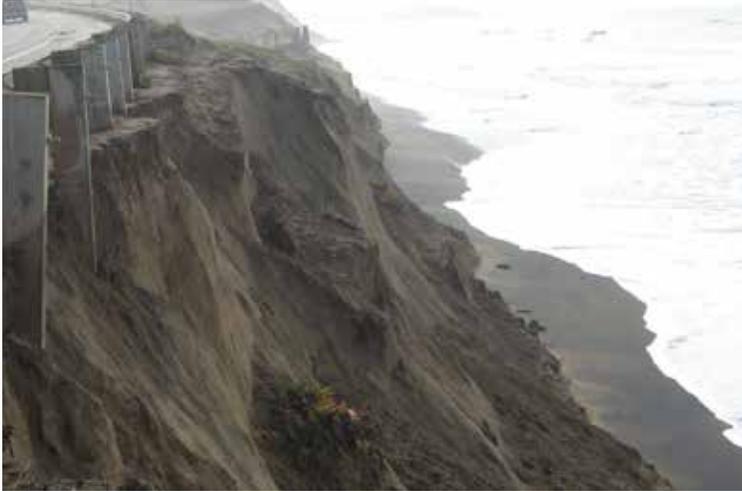
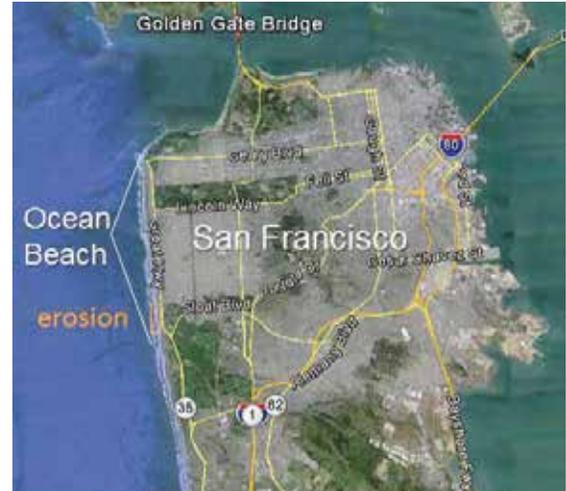
Left: The south end of Ocean Beach is eroding. Image credit: Steve Ortega, NPS. **Right:** Erosion below the Great Highway along Ocean Beach is believed to be exacerbated by development around San Francisco Bay. Image credit: NPS with photo from Google Earth 2013.

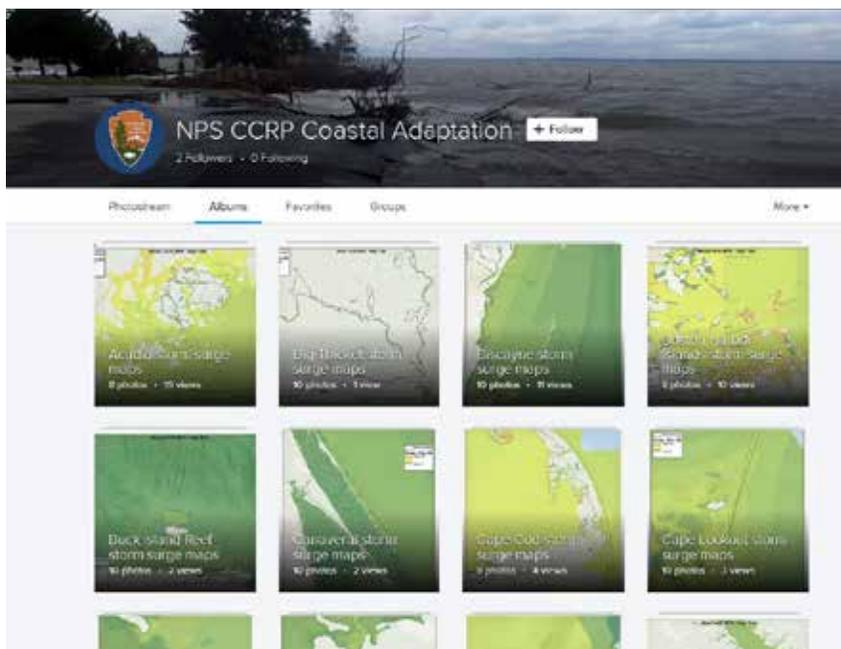
Storm surge maps completed for the parks (available at <https://www.flickr.com/photos/125040673@N03/sets/>). Image credit: NPS.

The division uses IPCC and US Army Corps of Engineers data to generate new data that can be projected on multiple time horizons to help the parks. A three-year project began in fiscal year 2013 to analyze rates of sea level change coupled with potential storm surge in 118 of the coastal parks in order to project, for each park, the combined elevations of storm surge and sea level by 2030, 2050, and 2100.

NOAA Sea, Lake and Overland Surges from Hurricanes (SLOSH) model data have already been incorporated into 34 foundation documents, 9 state of the parks reports, and various assistance requests (e.g., Gulf Islands National Seashore, Acadia National Park, Assateague Island National Seashore, Boston Harbor Islands National Recreation Area, Colonial National Historical Park, Gateway National Recreation Area, Fire Island National Seashore, and Statue of Liberty National Monument). Individual sea level change and storm surge projections for each park will be released in a full report during the NPS Centennial Celebration in fiscal year 2016. Interim products that have been supplied to the parks as part of foundation documents or state of the parks reports can be found at <https://irma.nps.gov>. Sea level change and storm surge data will be featured in the park atlas and as a separate interactive website. In the meantime, storm surge maps are already available at <https://www.flickr.com/photos/125040673@N03/sets/>.
