# Humboldt Bay (/refuge/Humboldt\_Bay)

## Salmon Creek Restoration

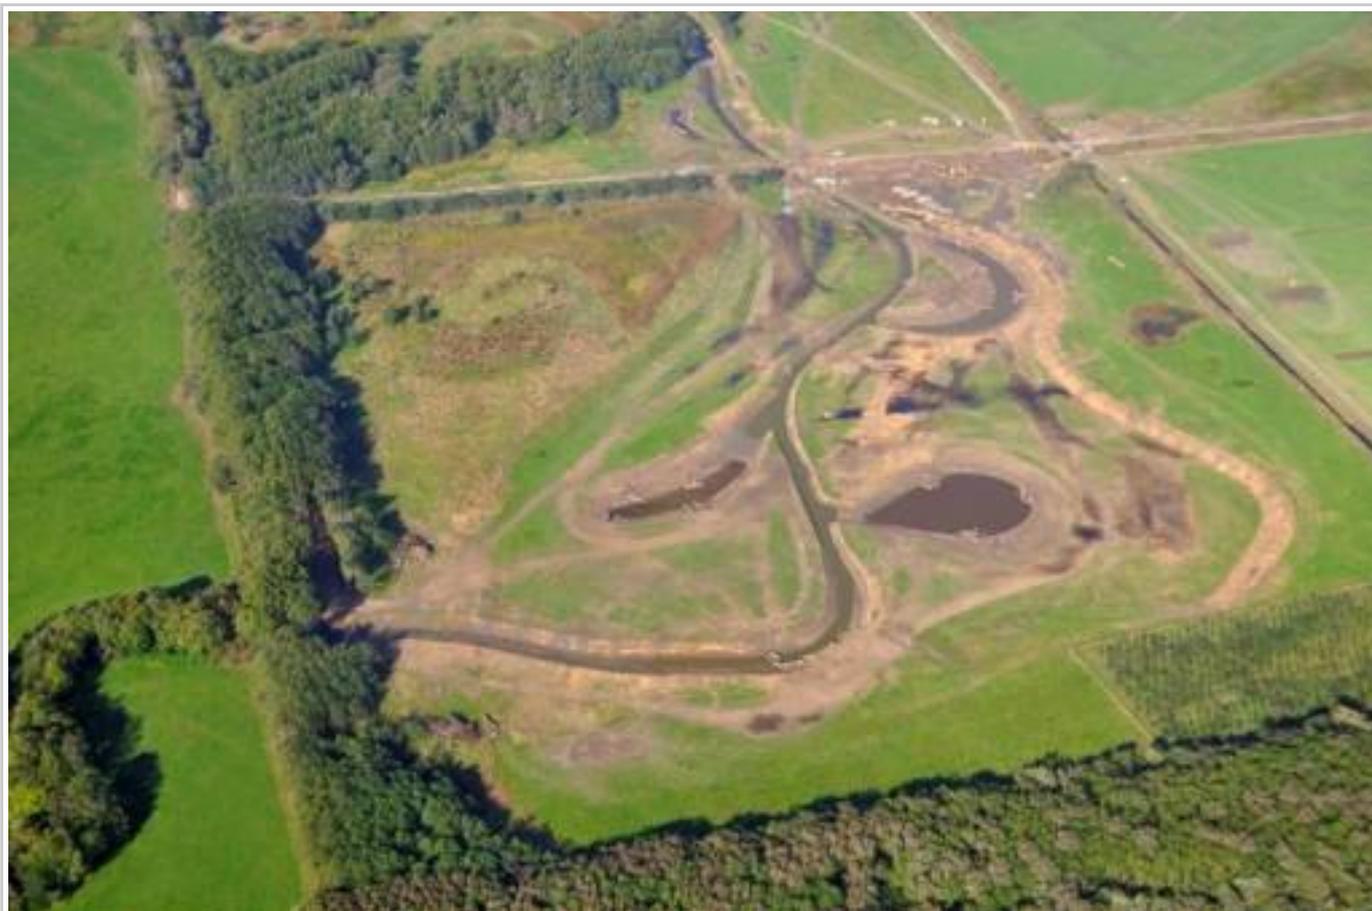
*Aerial photo of the restored meandering channel and oxbows of salmon creek.*

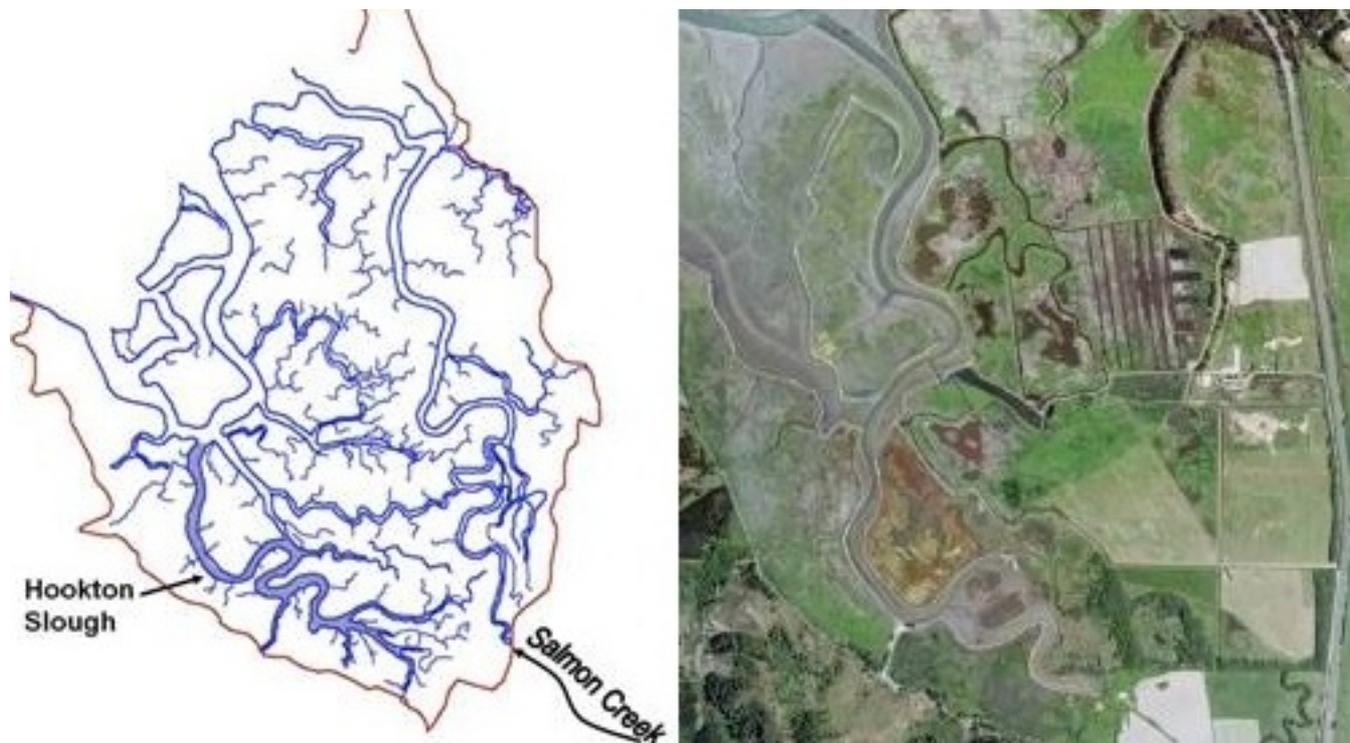
**The schematic on the left shows what the Salmon Creek delta looked like in 1870. The aerial photo to the right shows what the Salmon Creek delta looked like in 2009. Despite the significant changes, if you look closely, you can find spots that still match up with the historical channels.**

The Salmon Creek delta was historically tidal salt marsh with a mosaic of slough channels. However, these lands were reclaimed for grazing during the early 1900's through construction of dikes and levees, draining of salt marshes, straightening or relocation of stream channels, and installation of tide-gates to eliminate tidal influence. After these lands were acquired by Humboldt Bay NWR in 1988, management plans identified Salmon Creek as needing habitat improvements to reestablish estuarine and off-channel habitat. Off-channel habitat consists of sloughs, ponds and oxbows adjacent to the main channel that naturally would have slower water velocities, moderately higher temperatures and more large wood and food where fish (especially salmonids) can spend time while they make the physiological transition from a freshwater animal to saltwater animal. In comparison to pre-1900's conditions, almost all rearing habitat in the lower portion of Salmon Creek has been lost.

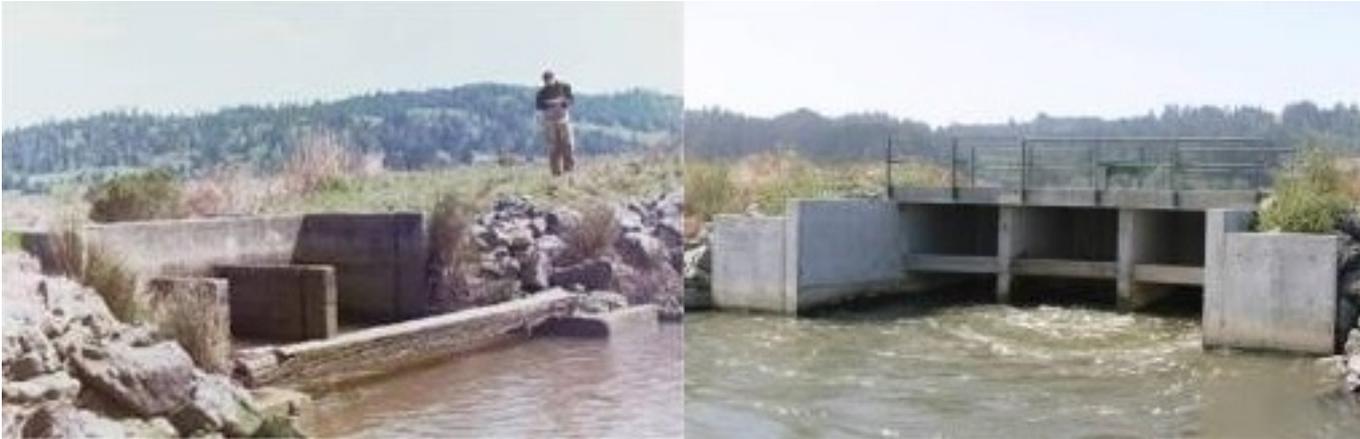
**The tidegate to the left restricted movement of bay water into the salmon creek channel. These were replaced with the tidegate shown in the picture to the right and another similar one at a separate location. The new tidegates have two side-hinged doors which provide better fish passage by reducing flow velocities and staying open longer through tide cycles. The middle door on the new tidegates is top-hinged but has a 2' x 4' slide door which can be kept open for constant movement of bay water into the upstream reaches of Salmon Creek, creating muted tidal conditions which improve ecosystem function.**

In 2006-2007, Phase I of the project increased Salmon Creek's tidal prism, tidal connectivity, and tidal influence by replacing an existing tide gate structure, constructing a new tide gate structure in the Salmon Creek overflow area, and re-connecting several off-channel ponds to the stream.

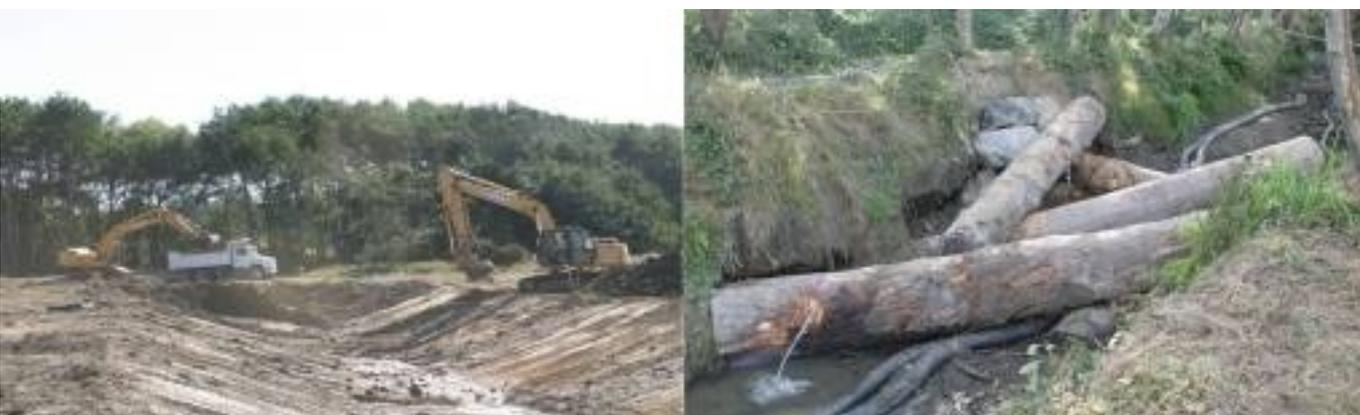
**The left picture shows two excavators digging the new channel. To the right is a newly connected channel with large wood added for salmonid and other species habitat.**

With increased tidal inundation, Phase II of the project focused on construction of 4,200 feet of new estuarine channel with a larger capacity and increased sinuosity. Much of this channel followed the alignment of slough channels through the historic marsh. Connection to the former ditched channel was maintained to allow it to serve as a backwater habitat. Five off-channel habitat features were also constructed to provide freshwater rearing habitat for salmonids in winter. A connecting channel between Salmon Creek and Cattail Creek was excavated to improve seasonal freshwater habitat and fish movement between the two systems. To further enhance this restored habitat, large log structures were added to the channels and ponds to provide resting and hiding places for fish and to add complexity to the stream hydrology. Over 200 logs of various sizes were anchored within banks to provide a diversity of habitat for fish. In the fall following construction, 12 different species of native trees and shrubs were planted adjacent to the channel and ponds to create a riparian component to this effort.

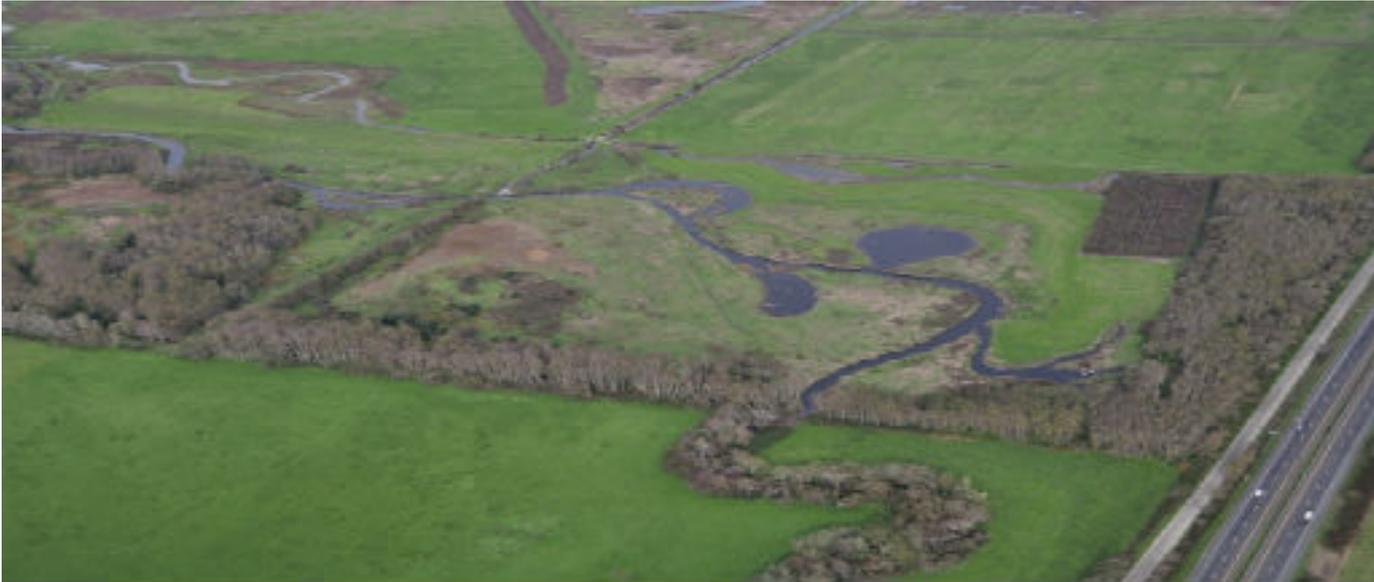
**This aerial photo shows the restored channel and off-channel habitat features in the middle, and the newly excavated Cattail Creek channel in the upper left.**

The excavation of the channel and ponds generated over 40,000 cubic yards of fill. Rather than dispose of this off site, the Refuge used this material to raise the elevation of a nearby area that was historically salt marsh but had subsided and turned to mudflat over recent decades. By adding material and increasing elevation, an area of new salt marsh was created. Within two years after the addition of the fill, this area was dominated by native plants, especially pickleweed (*Salicornia virginica*) This effort provides a habitat type that is lacking around the bay, as over 90% of salt marsh habitat in Humboldt Bay has been lost in the last 150 years.
